IPU Fuel Conditioning Case Study

Fuel Conditioning Packages

APPLICATION: Bank, Data Centre
LOCATION: London

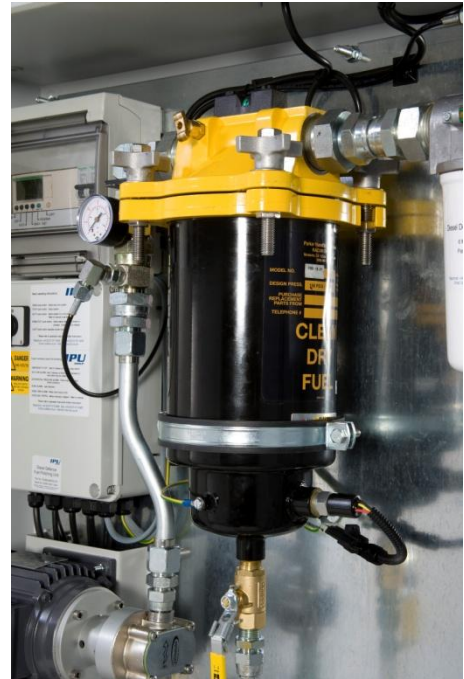
After carrying out thorough site surveys, the IPU fuel specialists established that the fuel was highly contaminated. Of the five sites investigated, one fuel tank had serious water contamination while the remaining four sites had fuel tanks containing critical levels of dirt and particle contamination.

Firstly, immediate action was to address the worst tanks. The tanks were cleaned using a fuel filtration rig, built by IPU, which is designed to remove particle contamination and water through depth filtration.

IPU then designed and commissioned Diesel Defence units for the storage tanks on all five sites. Once fitted, on-tank filtration systems continuously maintain and improve the cleanliness of stored fuel, simultaneously ensuring that any water particles are removed.
